***Preliminary  
Draft Remedial Investigation Report  
for  
Brownfield Cleanup Agreements  
Former General Motors Assembly Plant Site  
Sleepy Hollow, New York  
Volume I of II***

**General Motors Corporation  
Detroit, Michigan  
and  
Roseland/Sleepy Hollow, LLC  
Short Hills, New Jersey**

**December 2006**

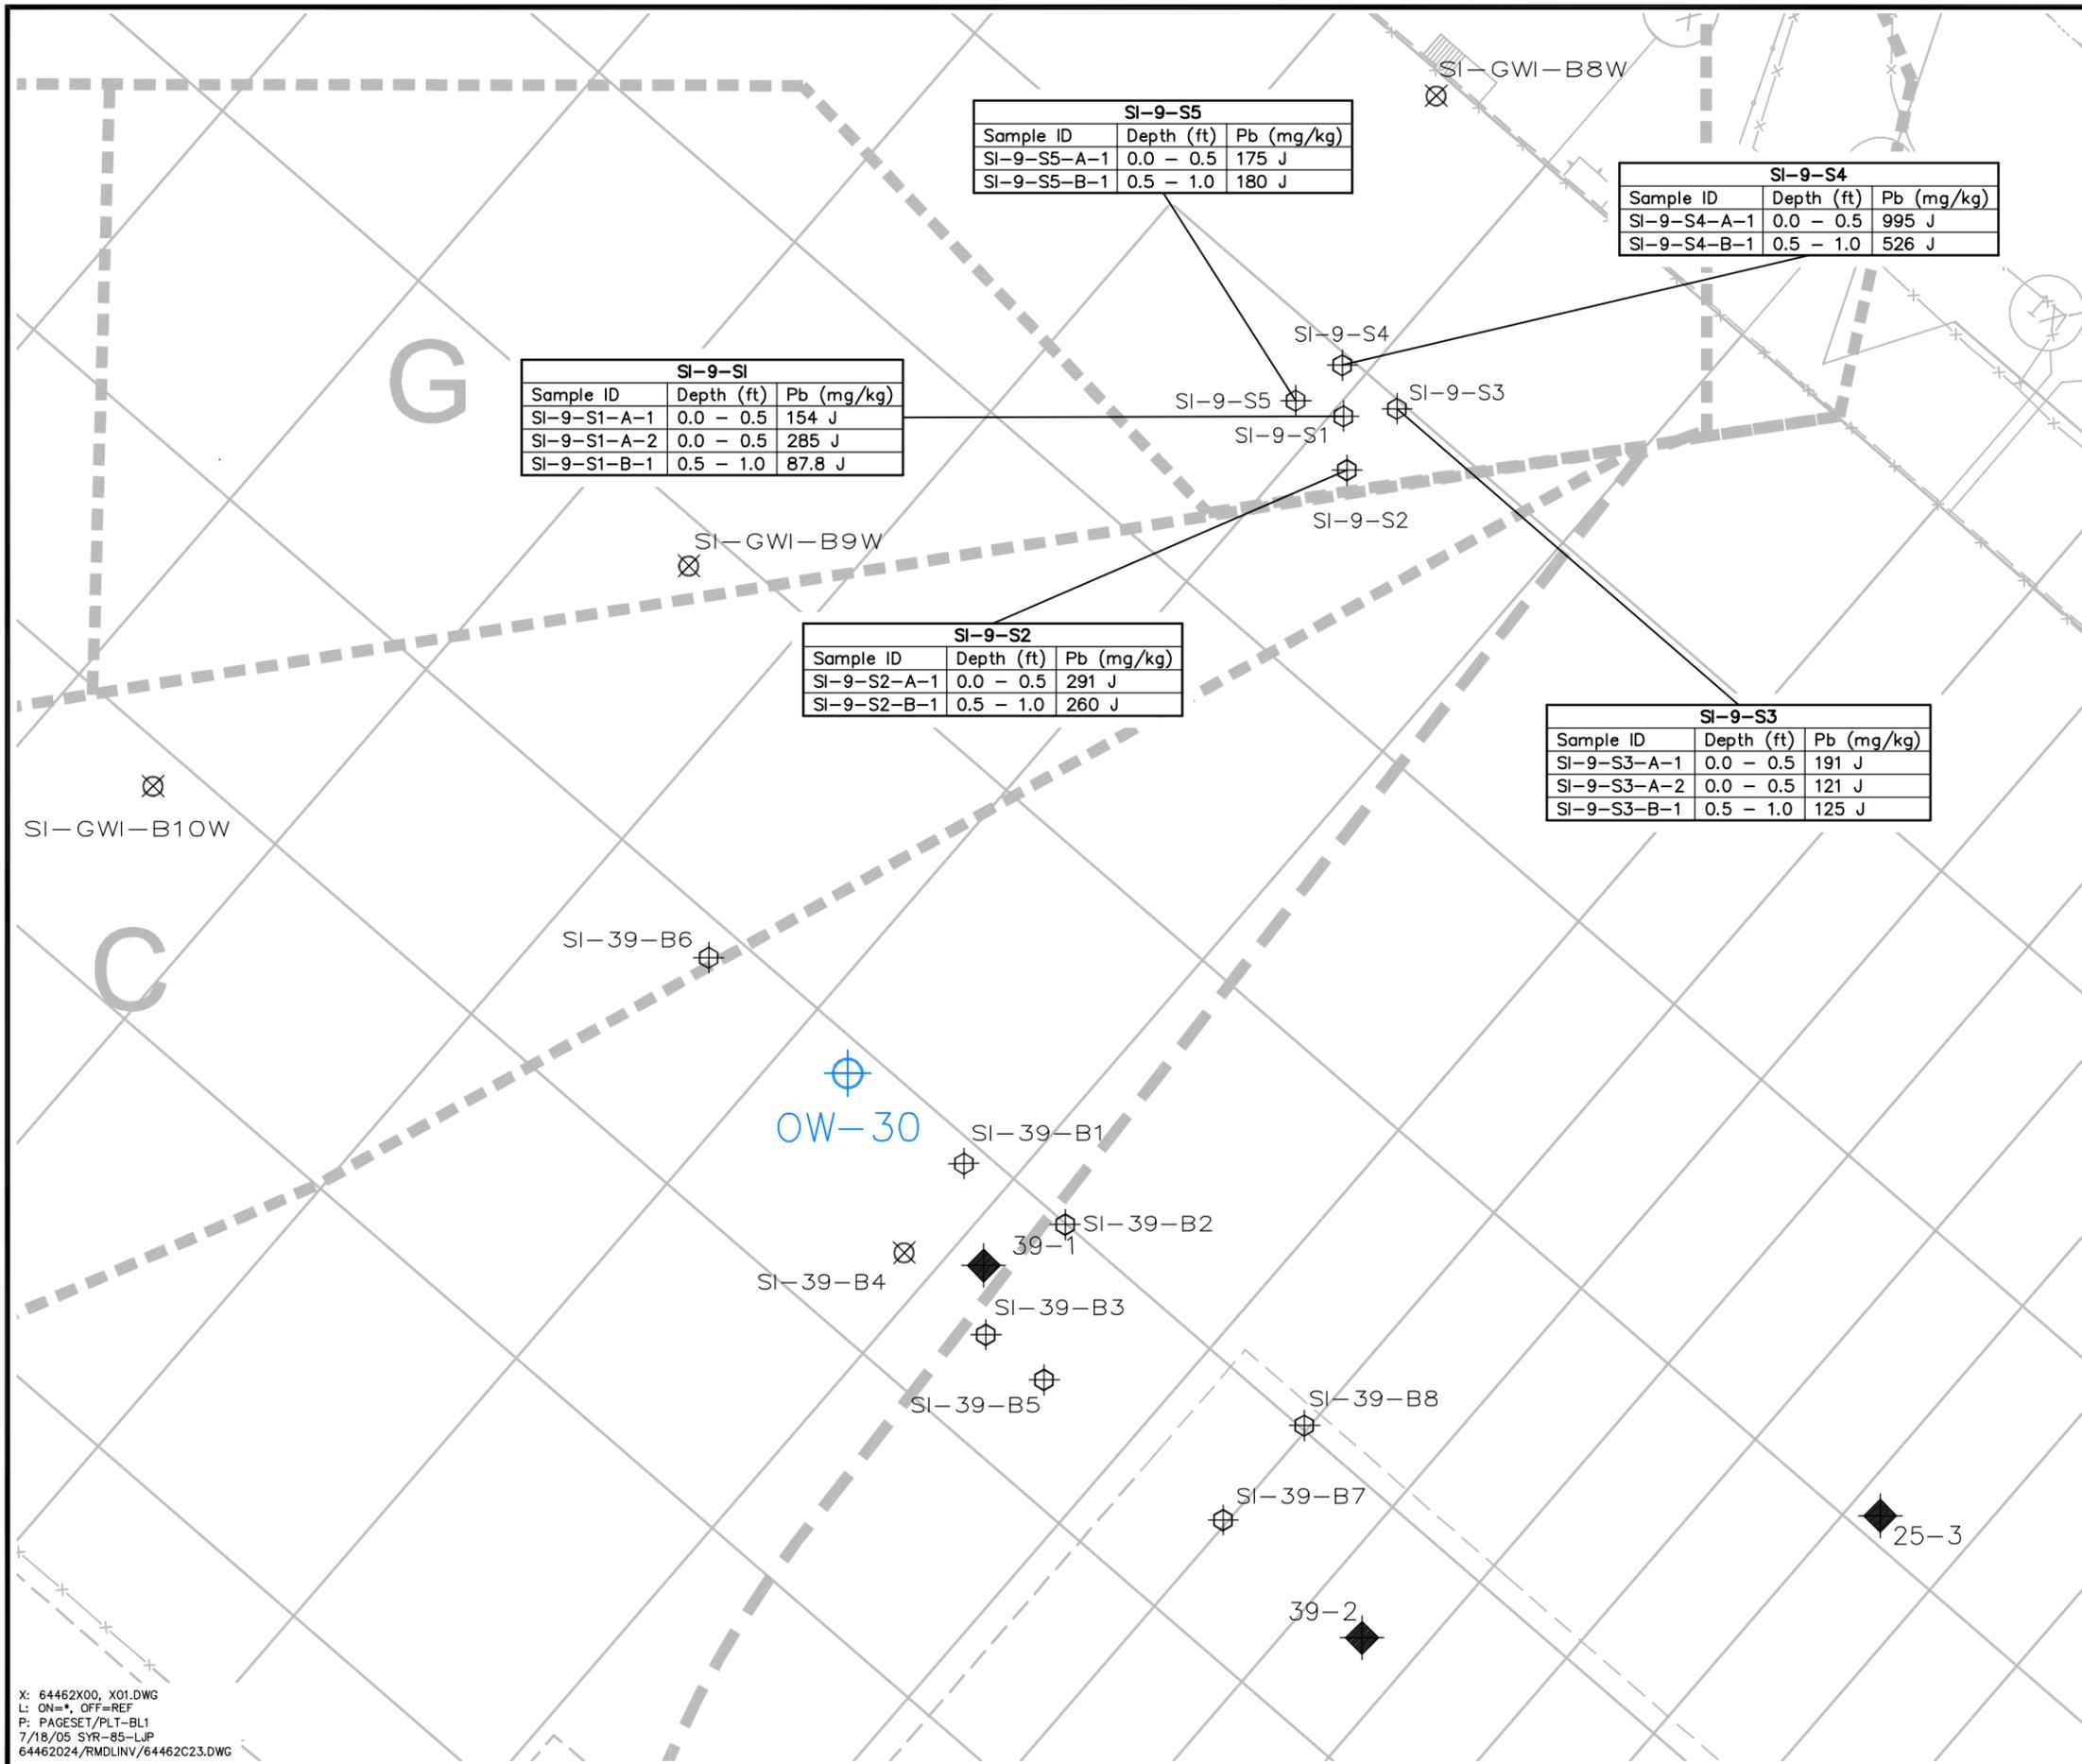
Within the basement under the Body Plant (PAOC 9), shallow soil samples were collected from depth intervals of 0 to 0.5 feet (ft) and 0.5 to 1 ft at each of five locations (total of 10 samples) and were submitted to the laboratory for analysis of total lead (Figure 5). The samples were collected using decontaminated stainless-steel hand trowels, as per the surface sampling methods described in Appendix A of the IWP.

SI-9-S5		
Sample ID	Depth (ft)	Pb (mg/kg)
SI-9-S5-A-1	0.0 - 0.5	175 J
SI-9-S5-B-1	0.5 - 1.0	180 J

SI-9-S4		
Sample ID	Depth (ft)	Pb (mg/kg)
SI-9-S4-A-1	0.0 - 0.5	995 J
SI-9-S4-B-1	0.5 - 1.0	526 J

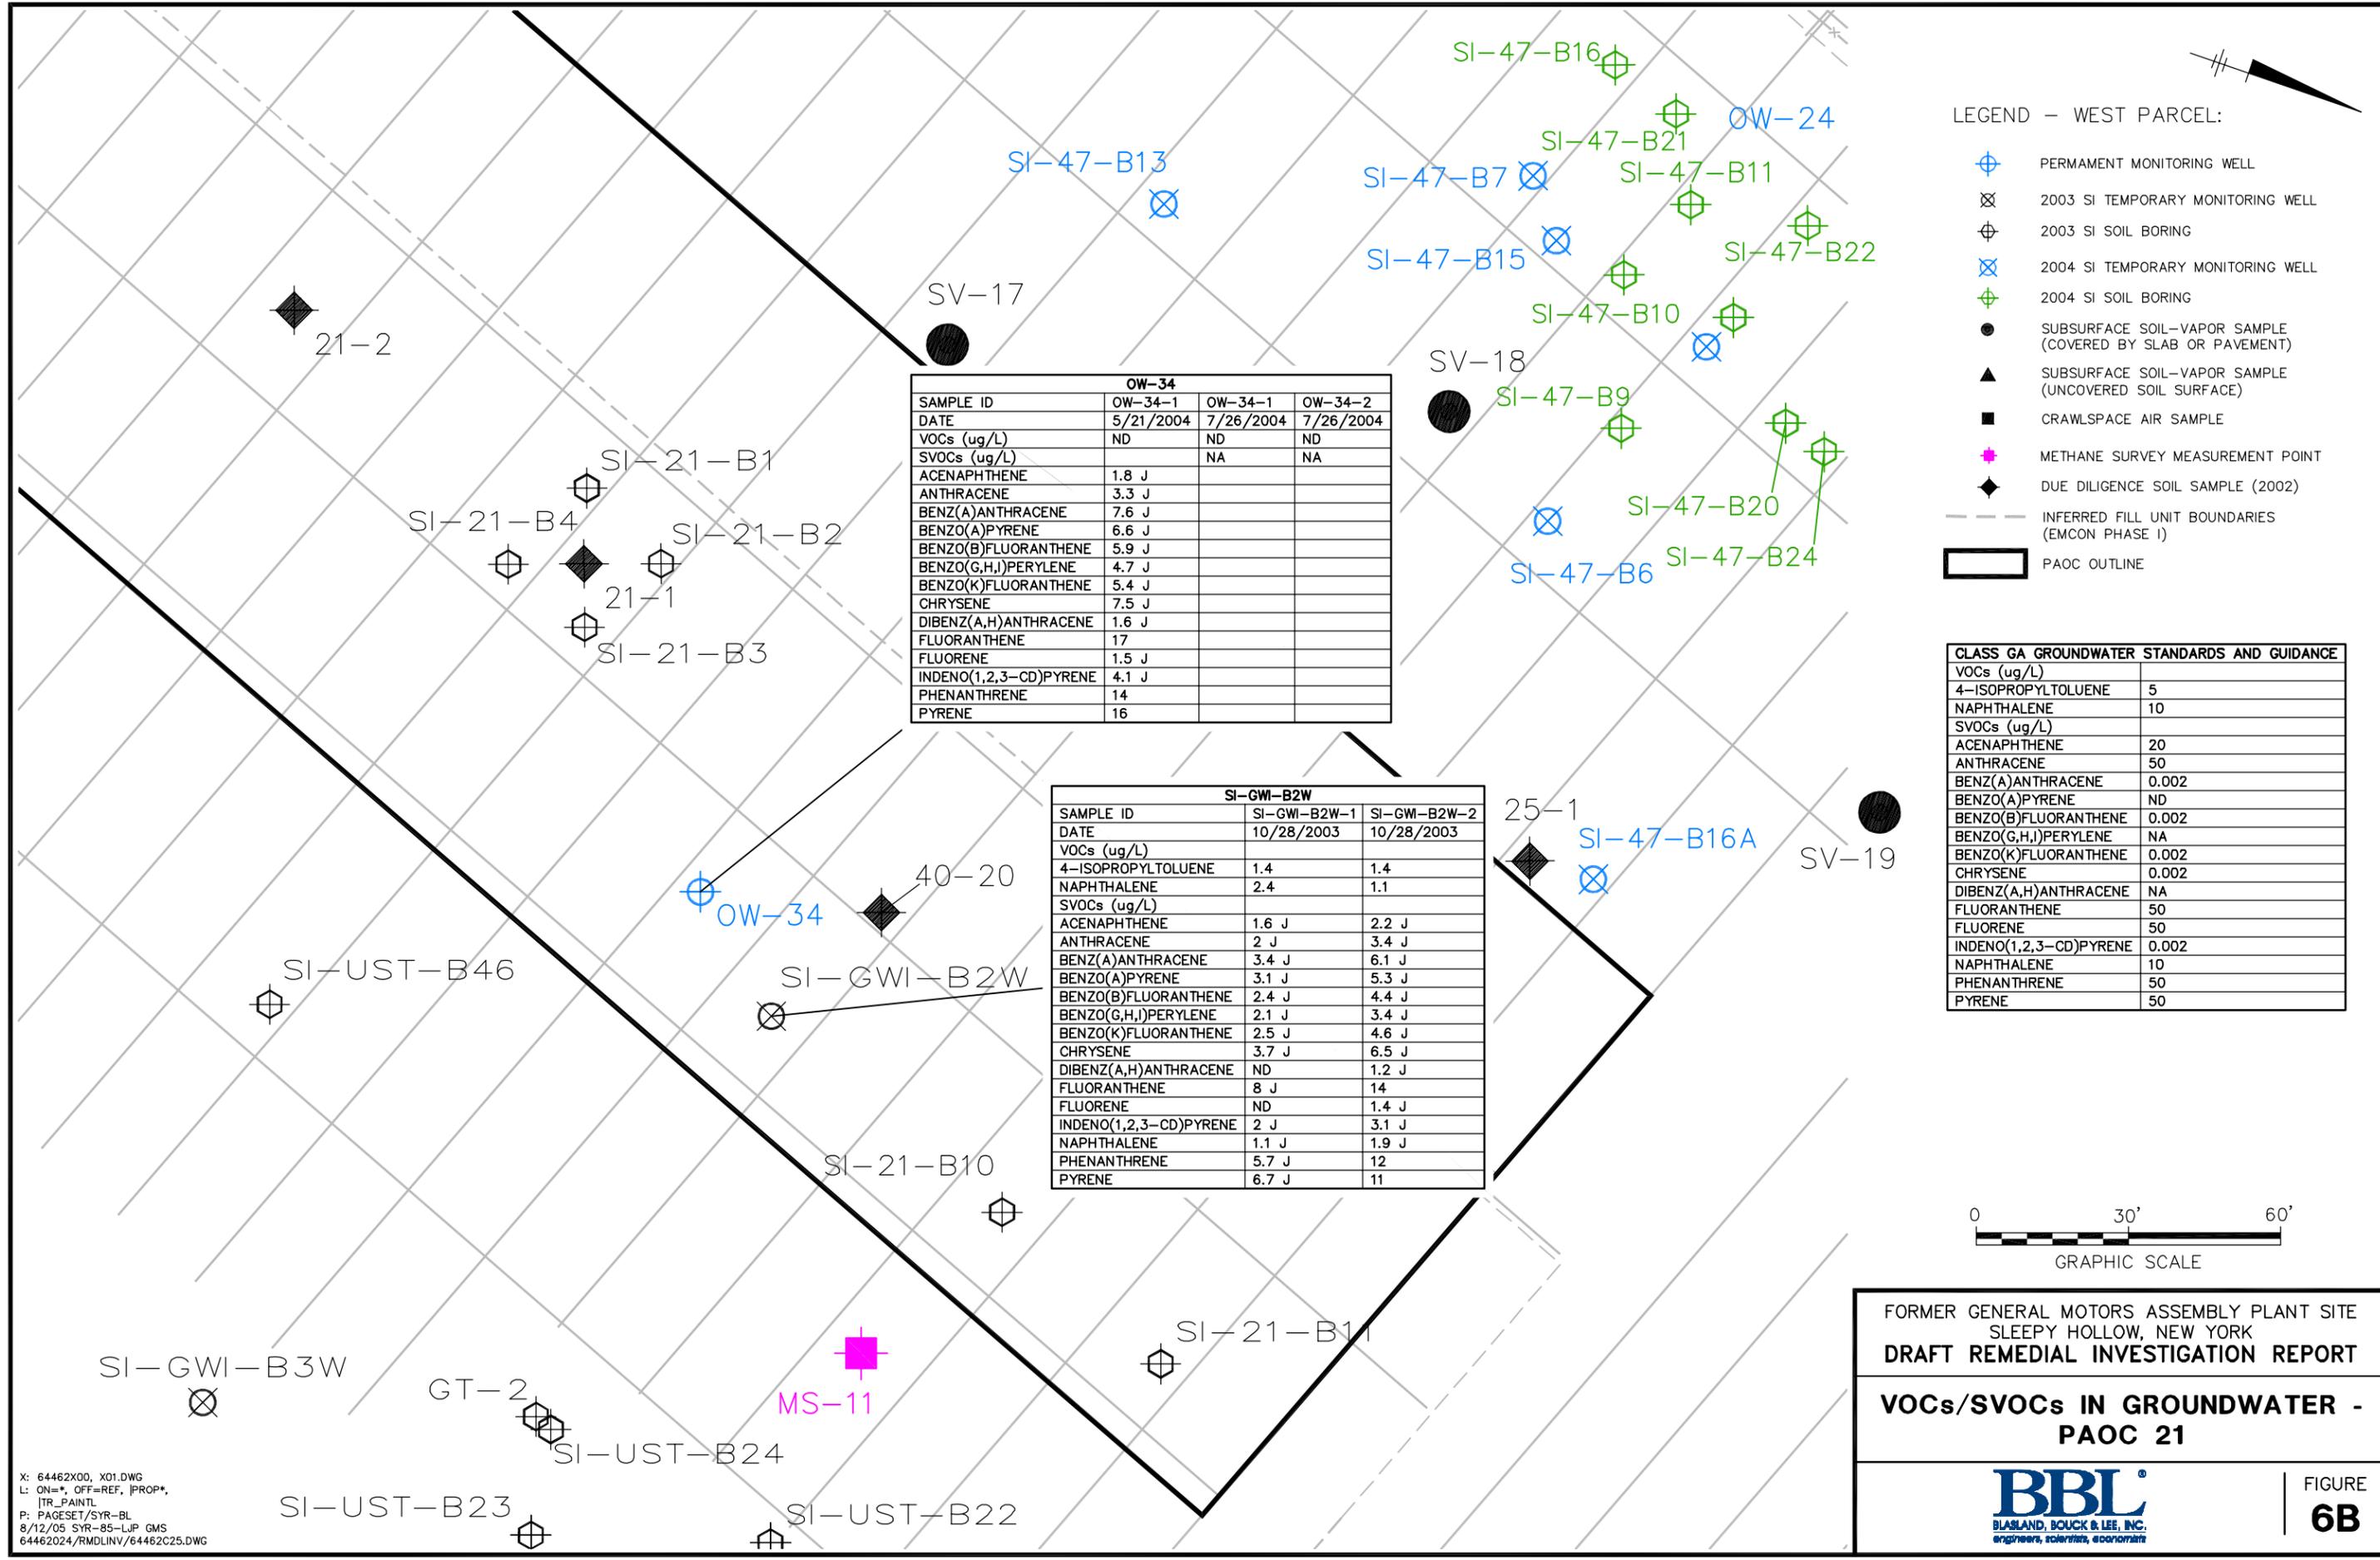
FIGURE  
**6B**

OW-34			
SAMPLE ID	OW-34-1	OW-34-1	OW-34-2
DATE	5/21/2004	7/26/2004	7/26/2004
VOCs (ug/L)	ND	ND	ND
SVOCs (ug/L)		NA	NA
ACENAPHTHENE	1.8 J		
ANTHRACENE	3.3 J		
BENZ(A)ANTHRACENE	7.6 J		
BENZO(A)PYRENE	6.6 J		
BENZO(B)FLUORANTHENE	5.9 J		
BENZO(G,H,I)PERYLENE	4.7 J		
BENZO(K)FLUORANTHENE	5.4 J		
CHRYSENE	7.5 J		
DIBENZ(A,H)ANTHRACENE	1.6 J		
FLUORANTHENE	17		
FLUORENE	1.5 J		
INDENO(1,2,3-CD)PYRENE	4.1 J		
PHENANTHRENE	14		
PYRENE	16

SI-GWI-B2W		
SAMPLE ID	SI-GWI-B2W-1	SI-GWI-B2W-2
DATE	10/28/2003	10/28/2003
VOCs (ug/L)		
4-ISOPROPYLTOLUENE	1.4	1.4
NAPHTHALENE	2.4	1.1
SVOCs (ug/L)		
ACENAPHTHENE	1.6 J	2.2 J
ANTHRACENE	2 J	3.4 J
BENZ(A)ANTHRACENE	3.4 J	6.1 J
BENZO(A)PYRENE	3.1 J	5.3 J
BENZO(B)FLUORANTHENE	2.4 J	4.4 J
BENZO(G,H,I)PERYLENE	2.1 J	3.4 J
BENZO(K)FLUORANTHENE	2.5 J	4.6 J
CHRYSENE	3.7 J	6.5 J
DIBENZ(A,H)ANTHRACENE	ND	1.2 J
FLUORANTHENE	8 J	14
FLUORENE	ND	1.4 J
INDENO(1,2,3-CD)PYRENE	2 J	3.1 J
NAPHTHALENE	1.1 J	1.9 J
PHENANTHRENE	5.7 J	12
PYRENE	6.7 J	11

FORMER GENERAL MOTORS ASSEMBLY PLANT SITE  
 SLEEPY HOLLOW, NEW YORK  
**DRAFT REMEDIAL INVESTIGATION REPORT**  
**VOCs/SVOCs IN GROUNDWATER -**  
**PAOC 21**

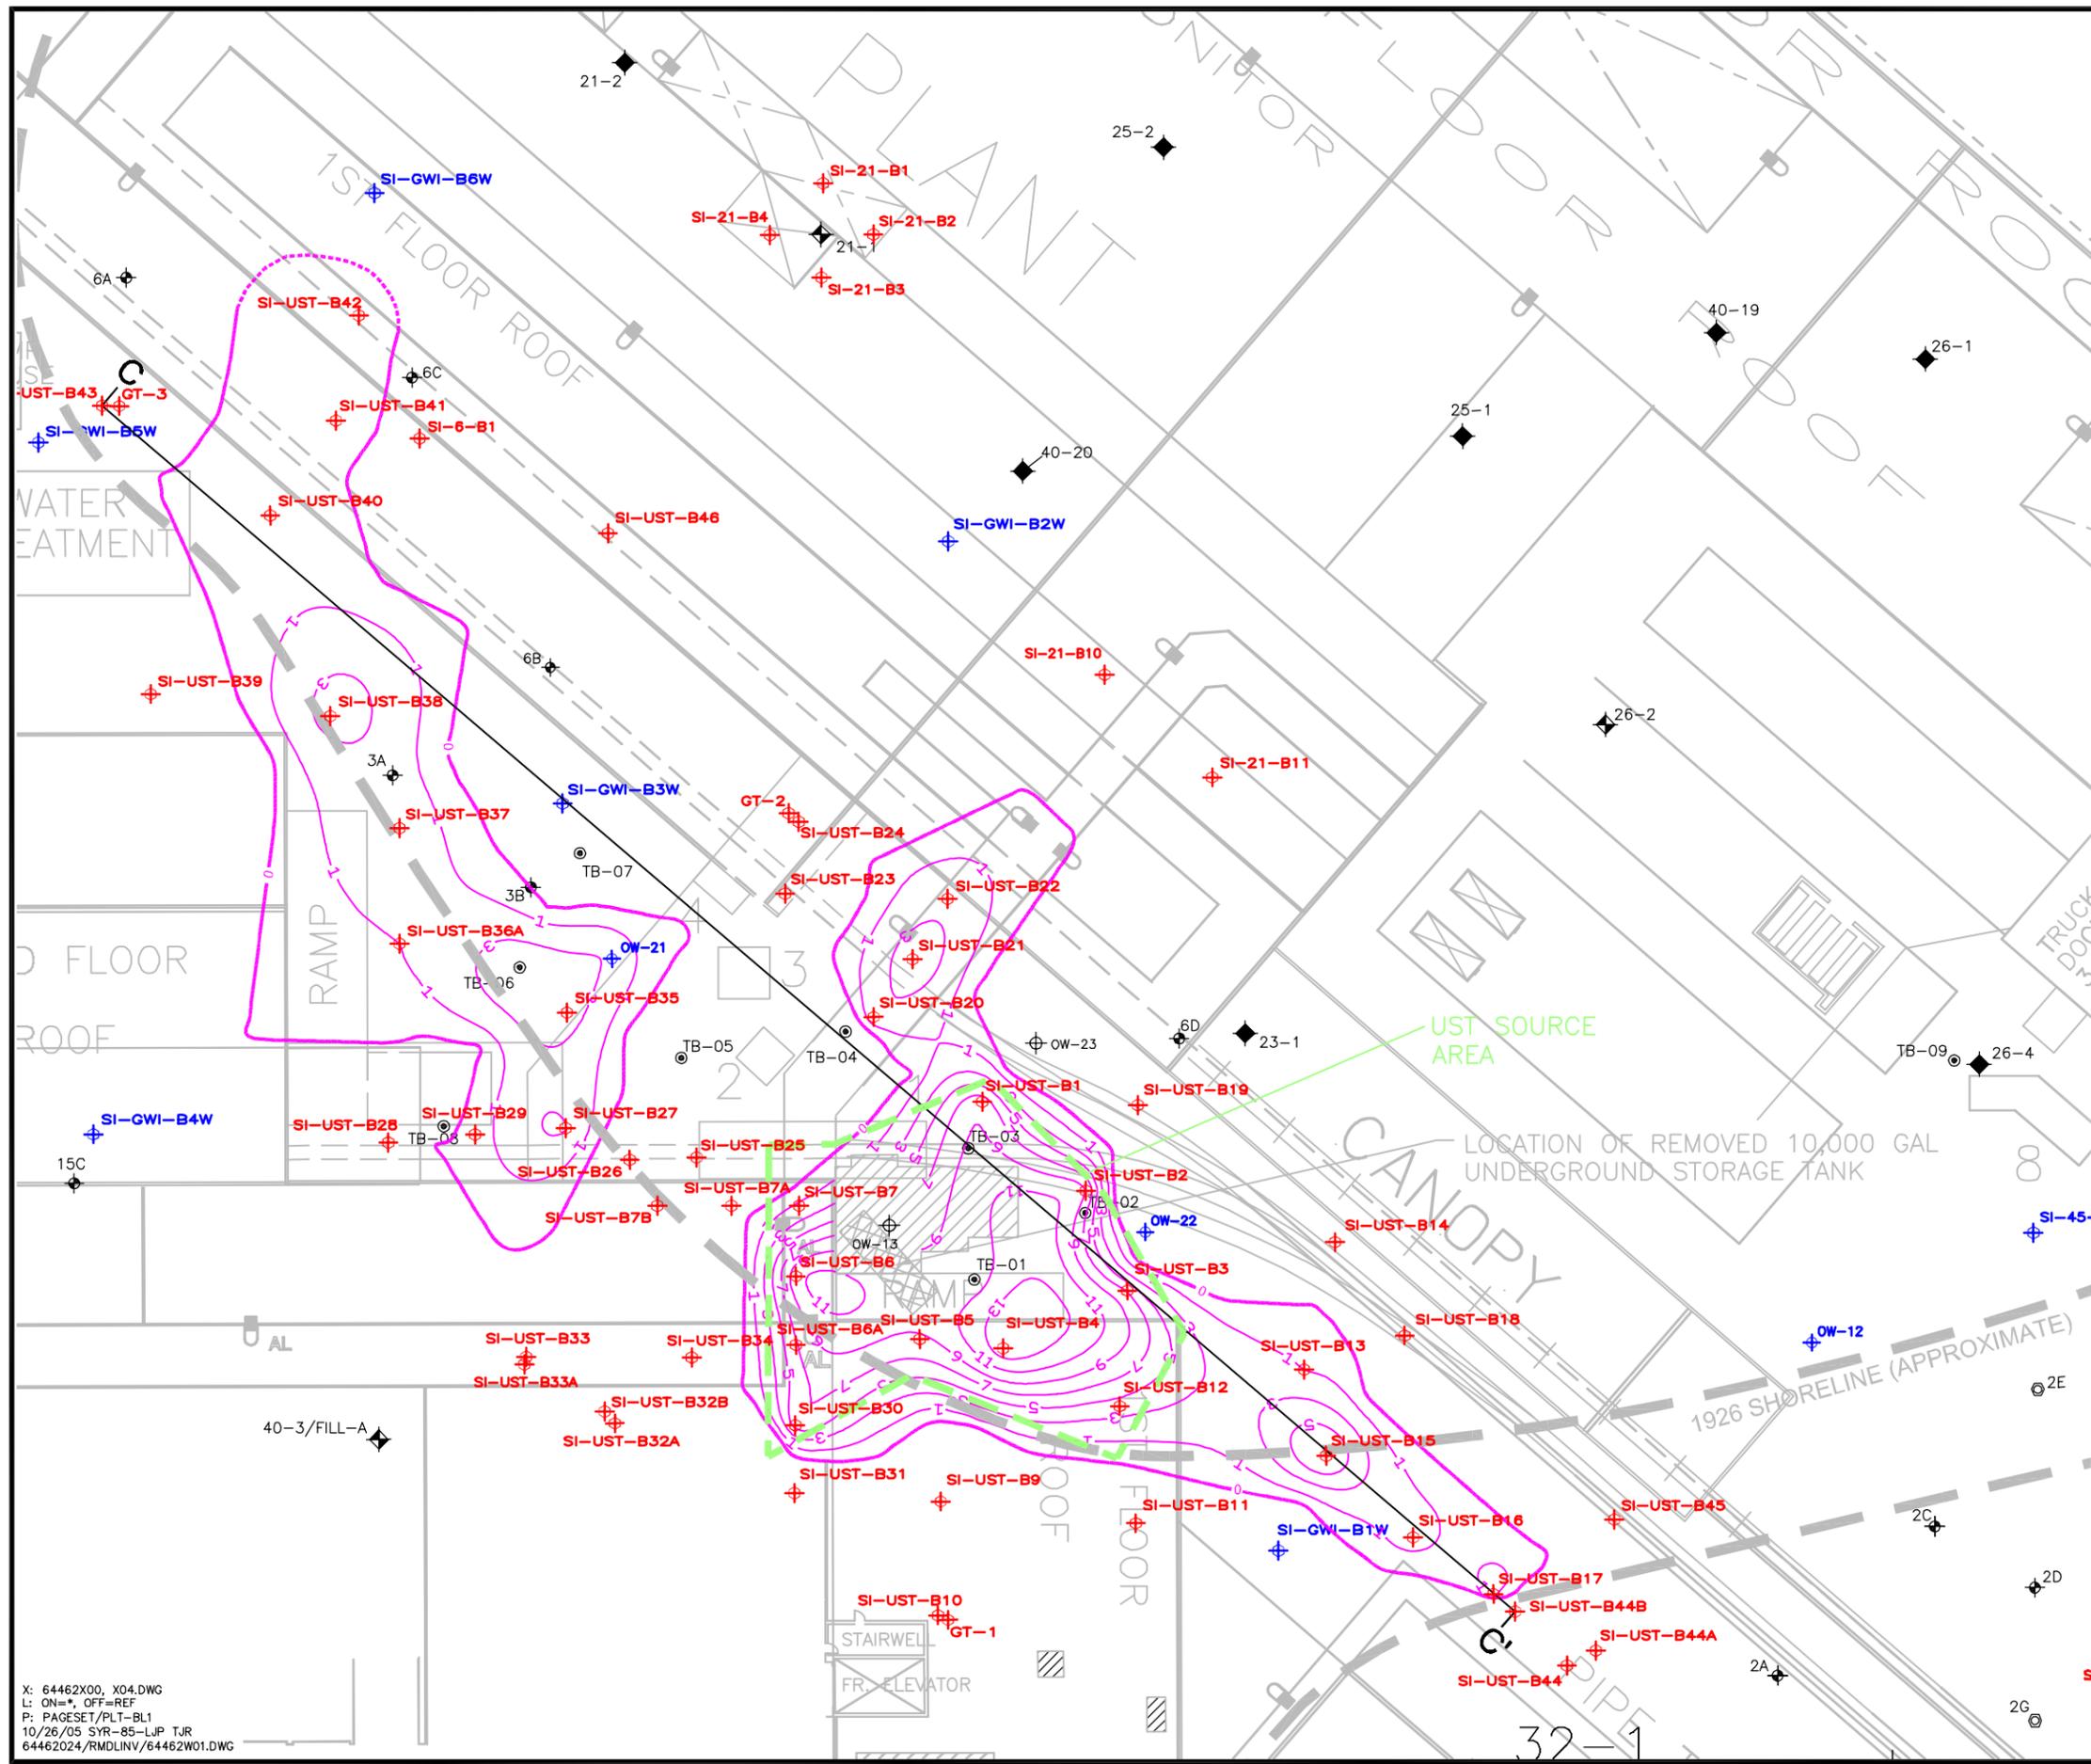
FIGURE  
**14A**

Iterative Geoprobe<sup>®</sup>/Macrocore<sup>®</sup> sampling was performed along a series of transect lines, as described in Table 2 and shown on Figures 14A through 14D, in order to further delineate the extent of residual oil associated with the former 10,000-gallon heating-oil UST. Previous investigations by EMCON revealed an abandoned UST (circa 1920s) and a body of grossly contaminated soil. The IRM performed by GM in 1998, removed the UST and over 700 cubic yards of grossly contaminated soil from this area, to the extent practicable without undermining the building foundations in that area. Any light non-aqueous phase petroleum product that may have been present before the IRM was not observed following the IRM. The RI investigated the extent of grossly contaminated soils that was not removed during the IRM, including the areas that were not previously accessible. Qualitative and semi-quantitative field screening methods (e.g., soil-water shake test, PID readings, visible petroleum sheen and odor) were used to assess the presence or absence of residual petroleum in and around this area.

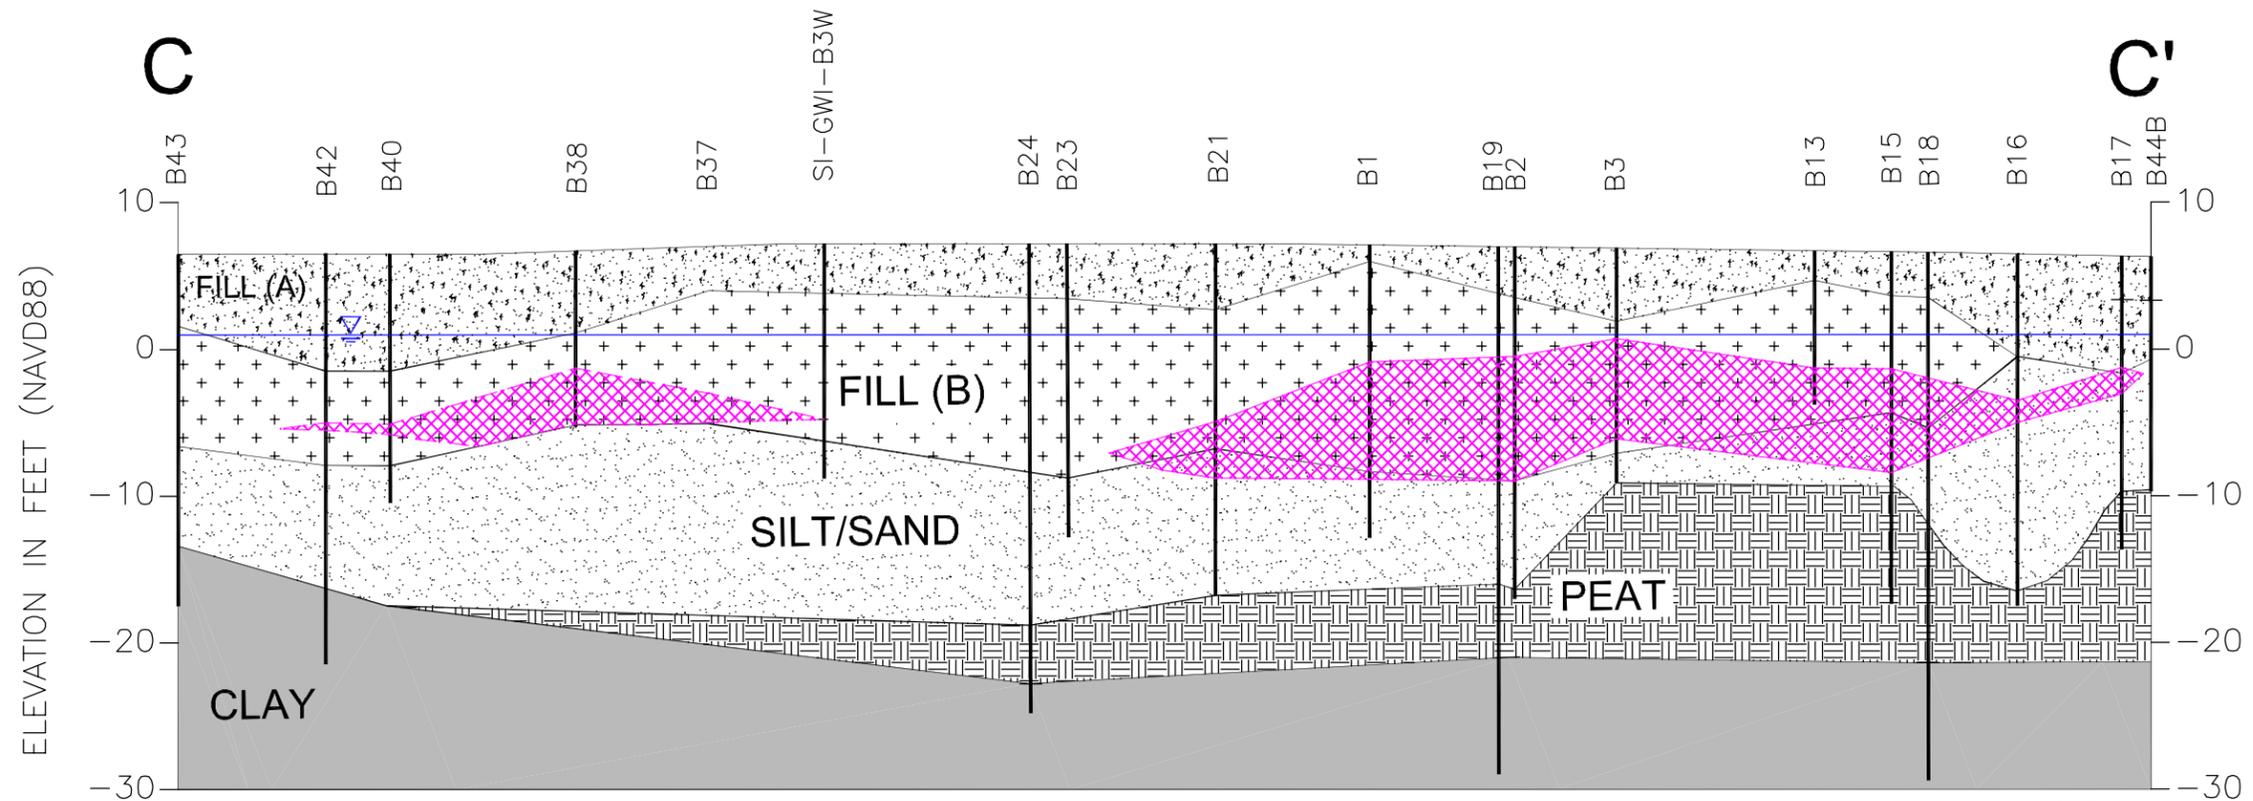
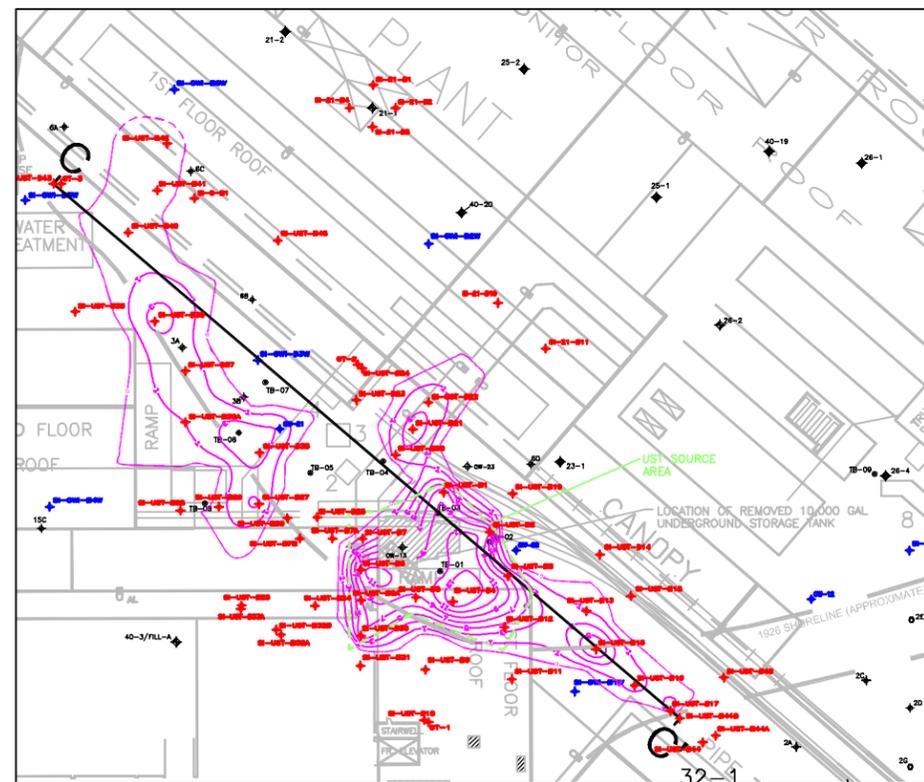
FIGURE  
**14B**

- CLAY Massive CLAY (marsh deposits), with up to 25% macroscopic organic matter and localized PEAT-rich horizons, stiff, compact, stratified (undisturbed).

- Evidence of oil contamination observed ( e.g., staining, odor, sheen, PID readings >100 ppm).

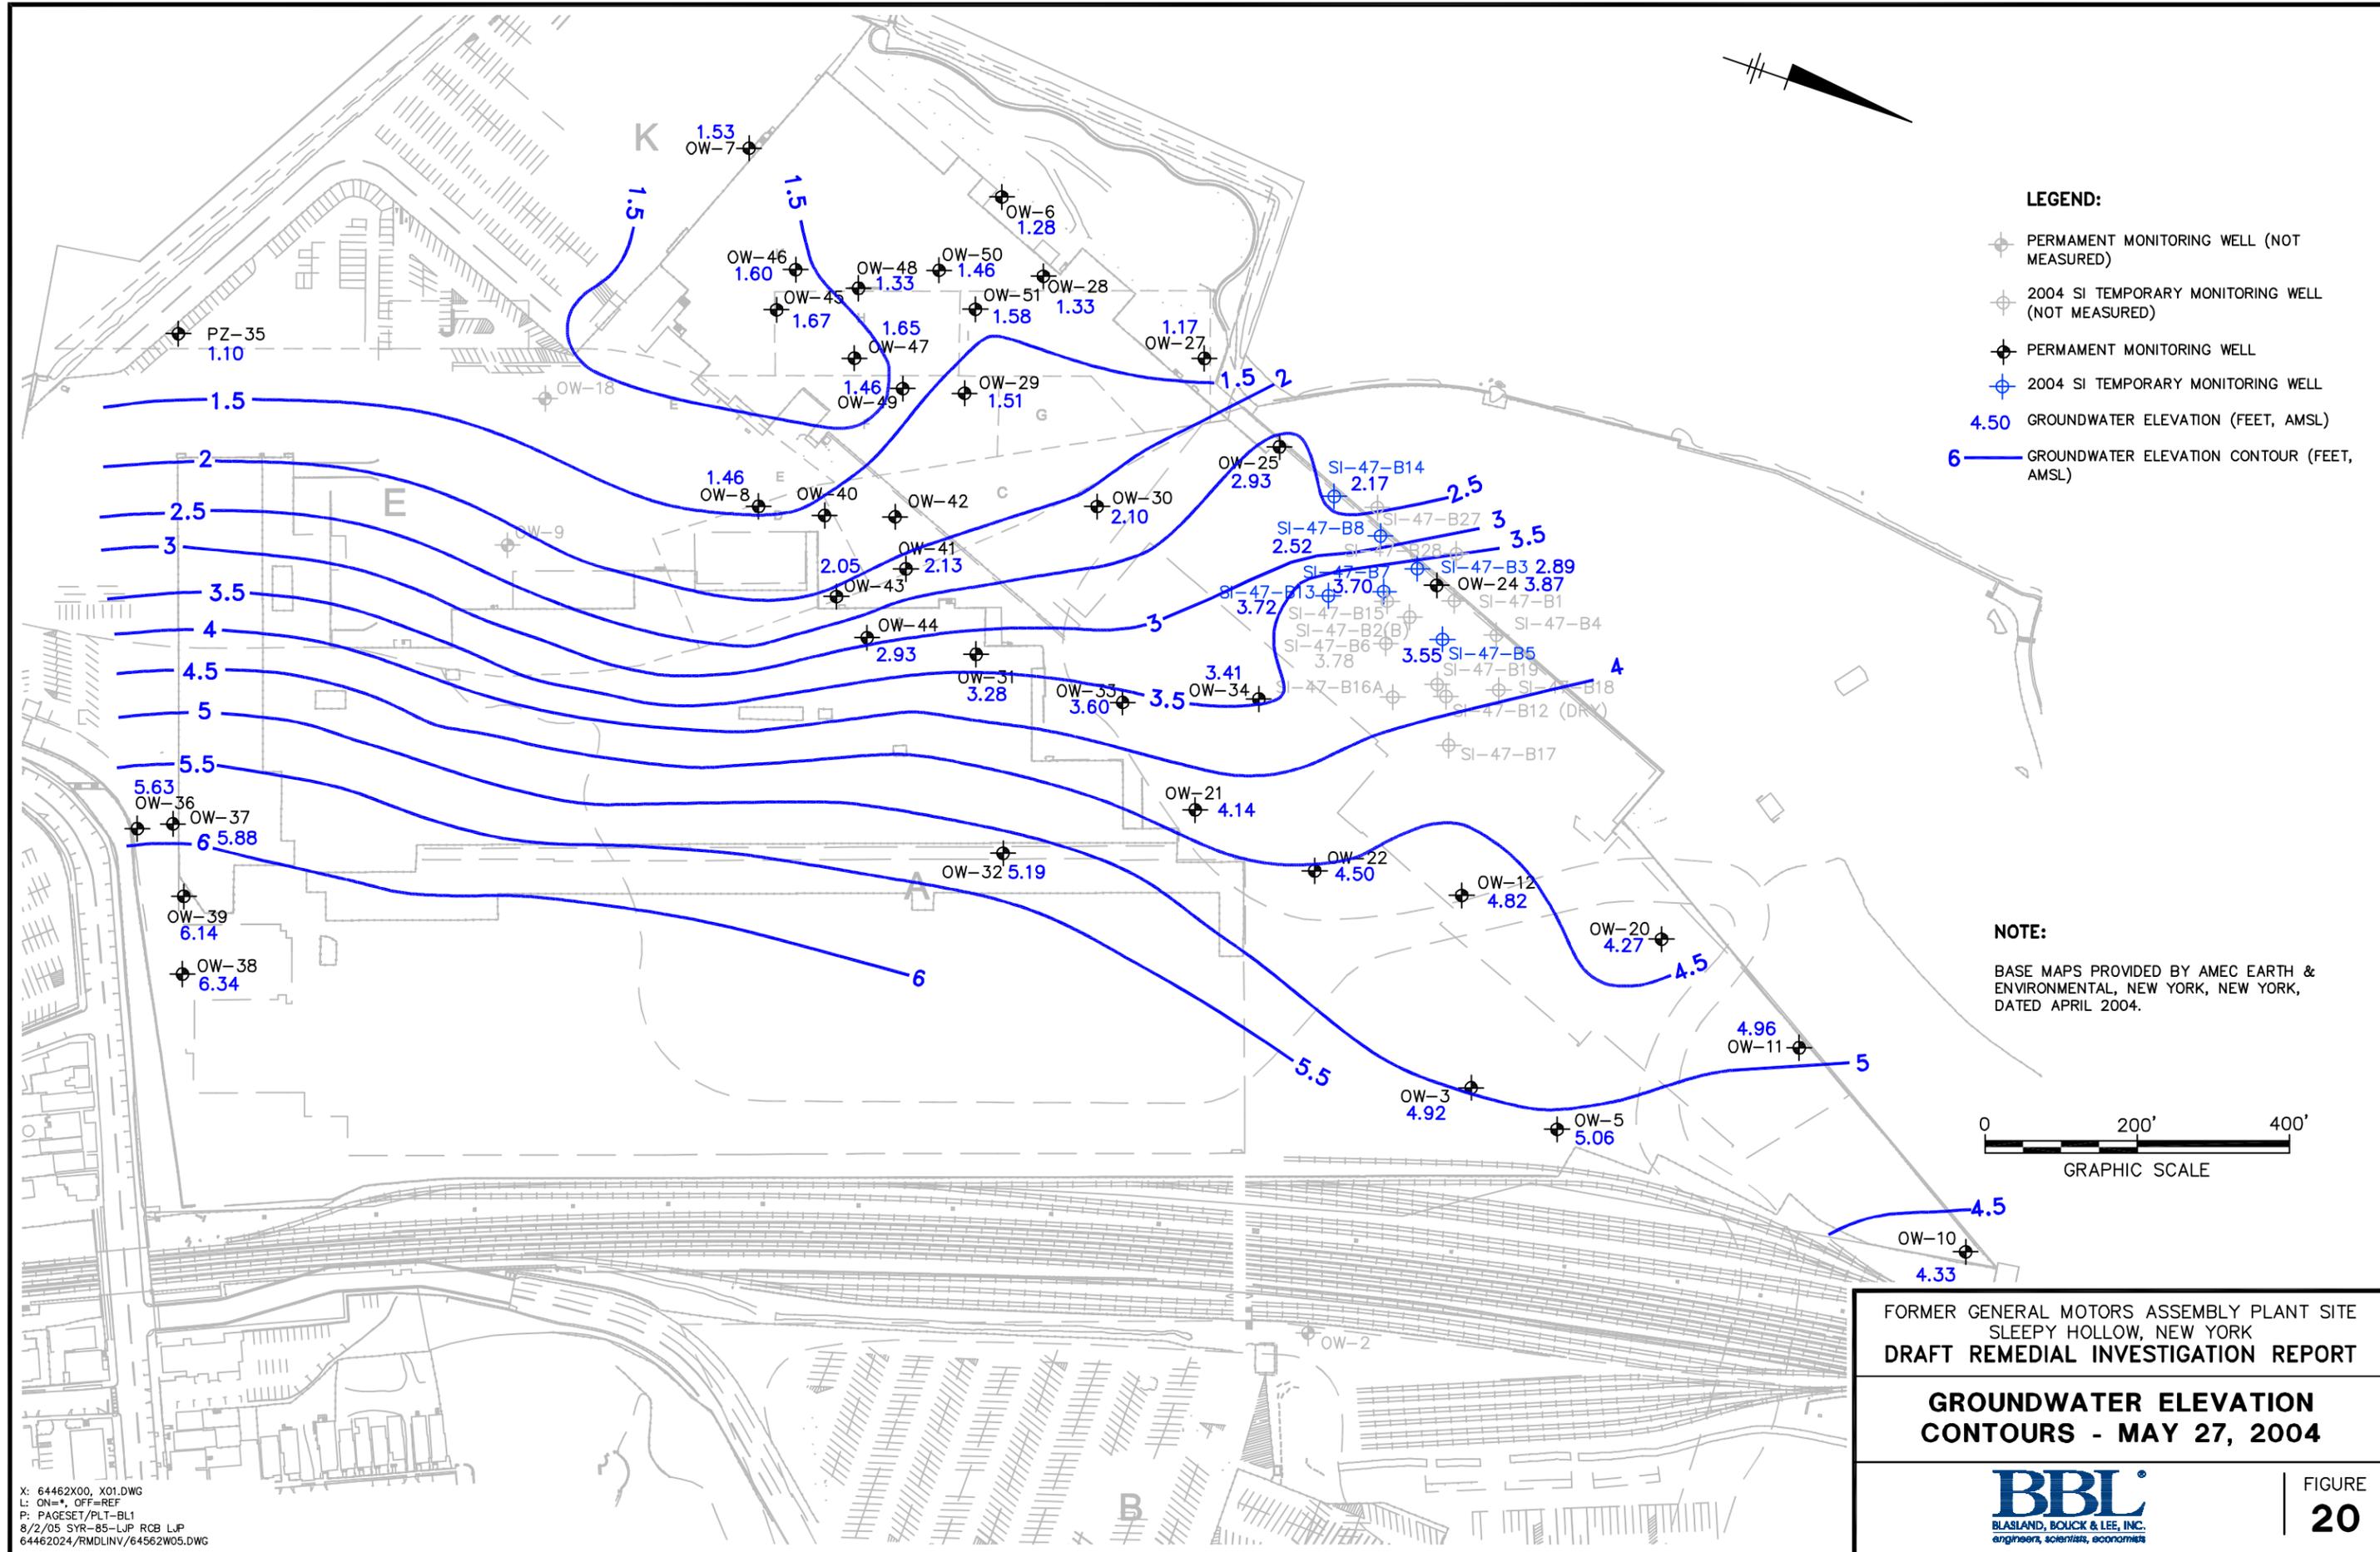
FIGURE  
**20**

Based on groundwater elevations obtained during spring 1997 from 23 groundwater monitoring wells onsite, EMCON determined that the direction of groundwater flow is southwest toward the Hudson River with local variations (see Section 6.2 for additional details). Groundwater flow across the East Parcel (east of the railroad tracks) is generally to the west, while flow across the West Parcel (west of the railroad tracks) is generally to the south-southwest. It is noted that the configuration of the groundwater contours appears to be somewhat influenced by the former Pocantico Creek and Bay, which used to run west across the East Parcel and southwest under the Chassis Plant on the West Parcel.

**GROUNDWATER ELEVATION  
 CONTOURS - MAY 27, 2004**
